# Laser-Induced Damage Threshold (LIDT) Measurement Report

## ISO21254-2: S-on-1 Test Procedure

Sample: R14006-10

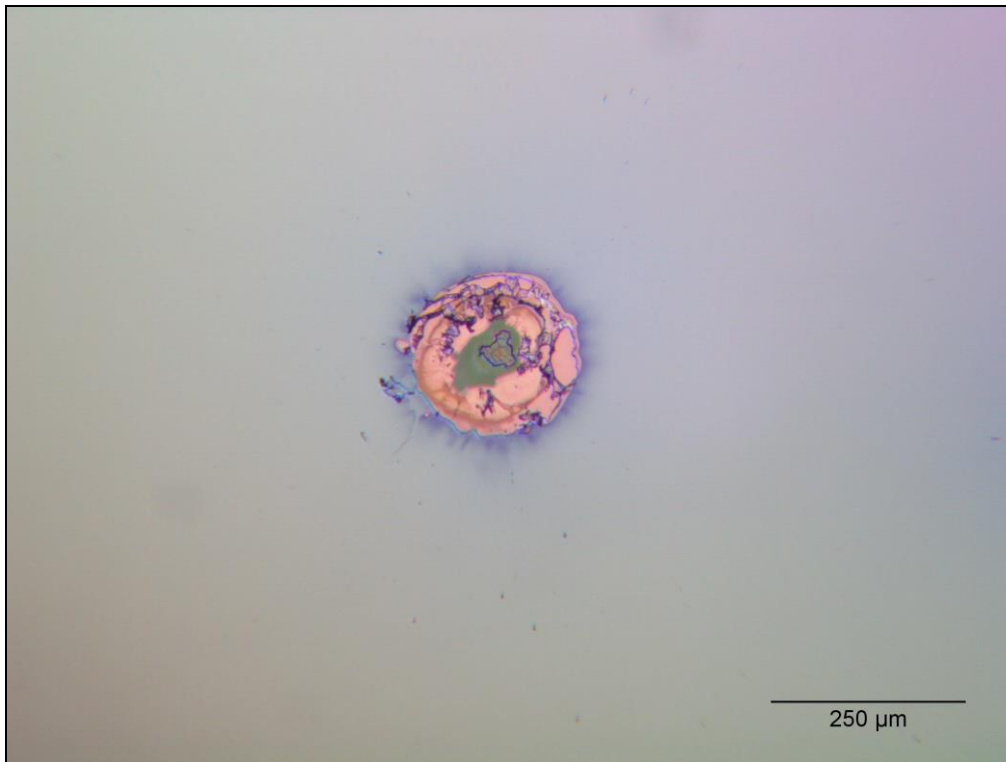
**Fig. 3. Typical front surface damage morphology  
(Energy density 30.21 J/cm<sup>2</sup>, damage after 2 pulses)**

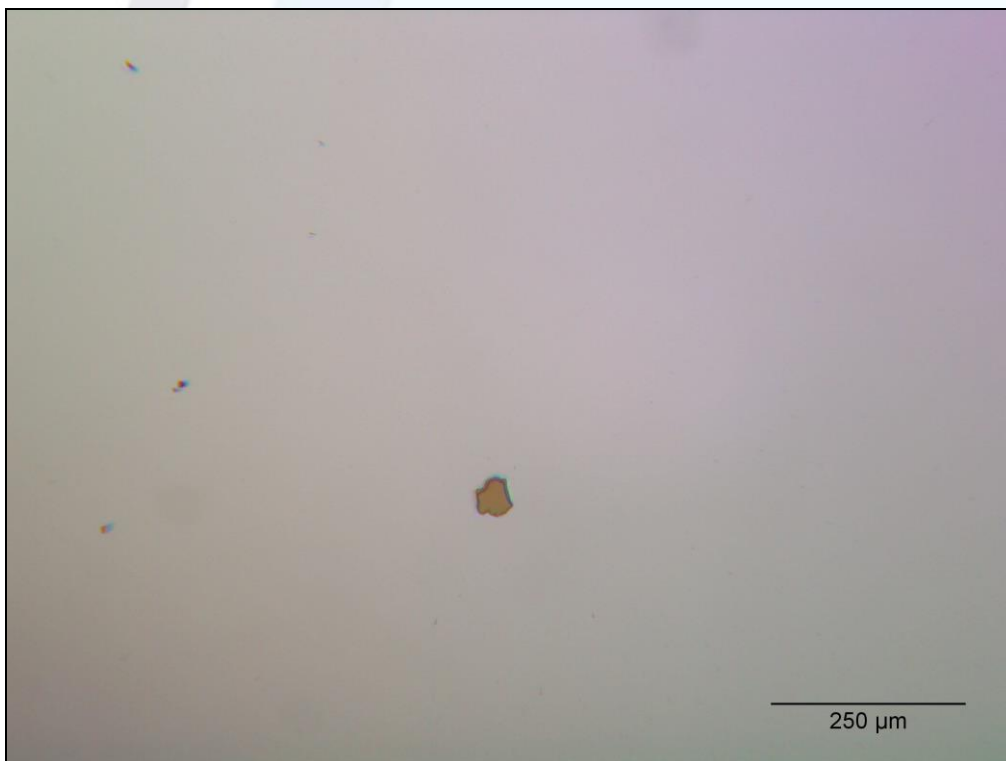
**Fig. 4. Typical front surface damage morphology  
(Energy density 12.64 J/cm<sup>2</sup>, damage after 1000 pulses)**

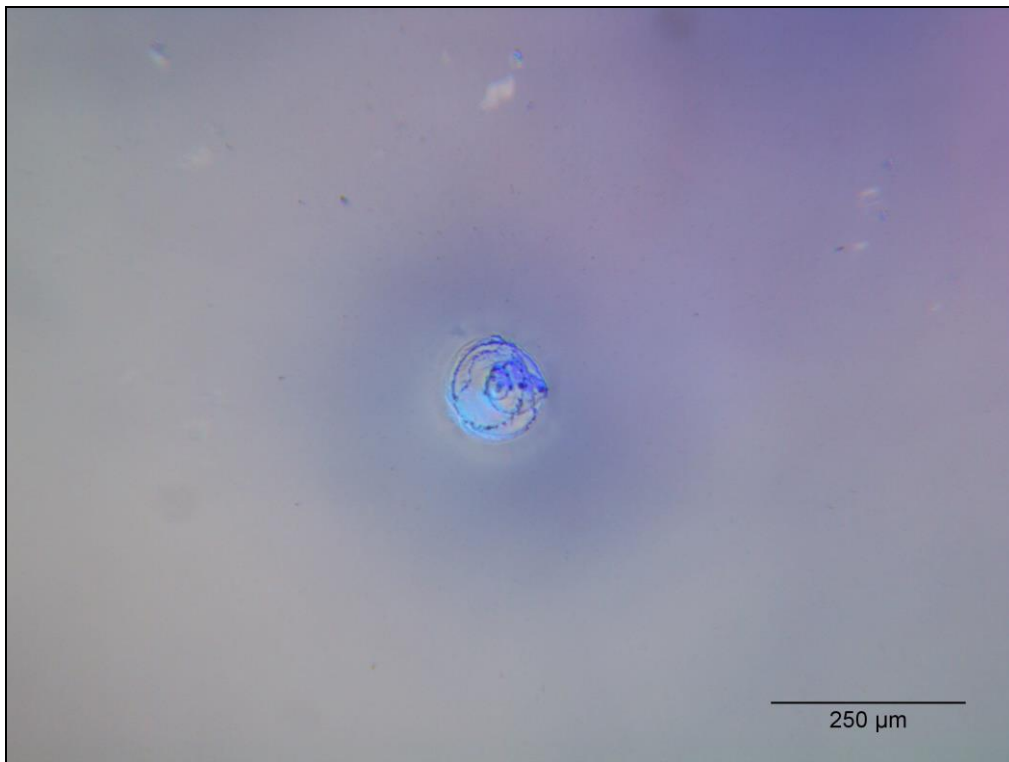
Fig. 5. Typical rear surface damage morphology  
(Energy density 50.18 J/cm<sup>2</sup>, damage after 8 pulses)

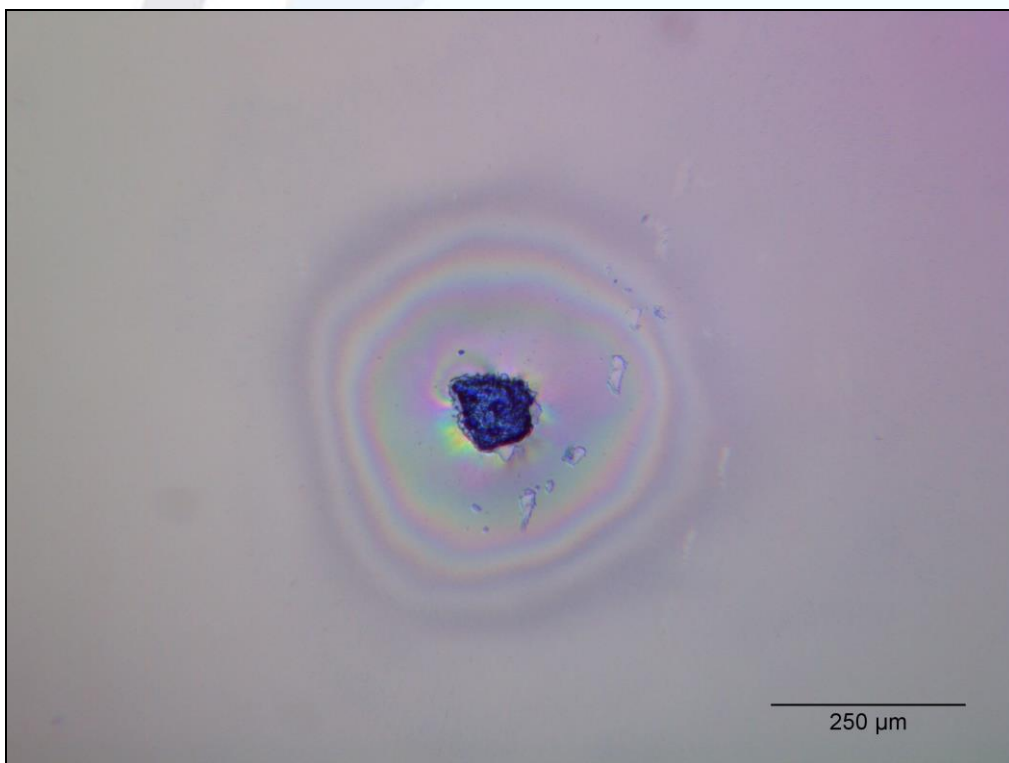
Fig. 6. Typical rear surface damage morphology  
(Energy density 17.60 J/cm<sup>2</sup>, damage after 1000 pulses)
