# Laser-Induced Damage Threshold (LIDT) Measurement Report

## ISO21254-2: S-on-1 Test Procedure

Sample: R14006-11

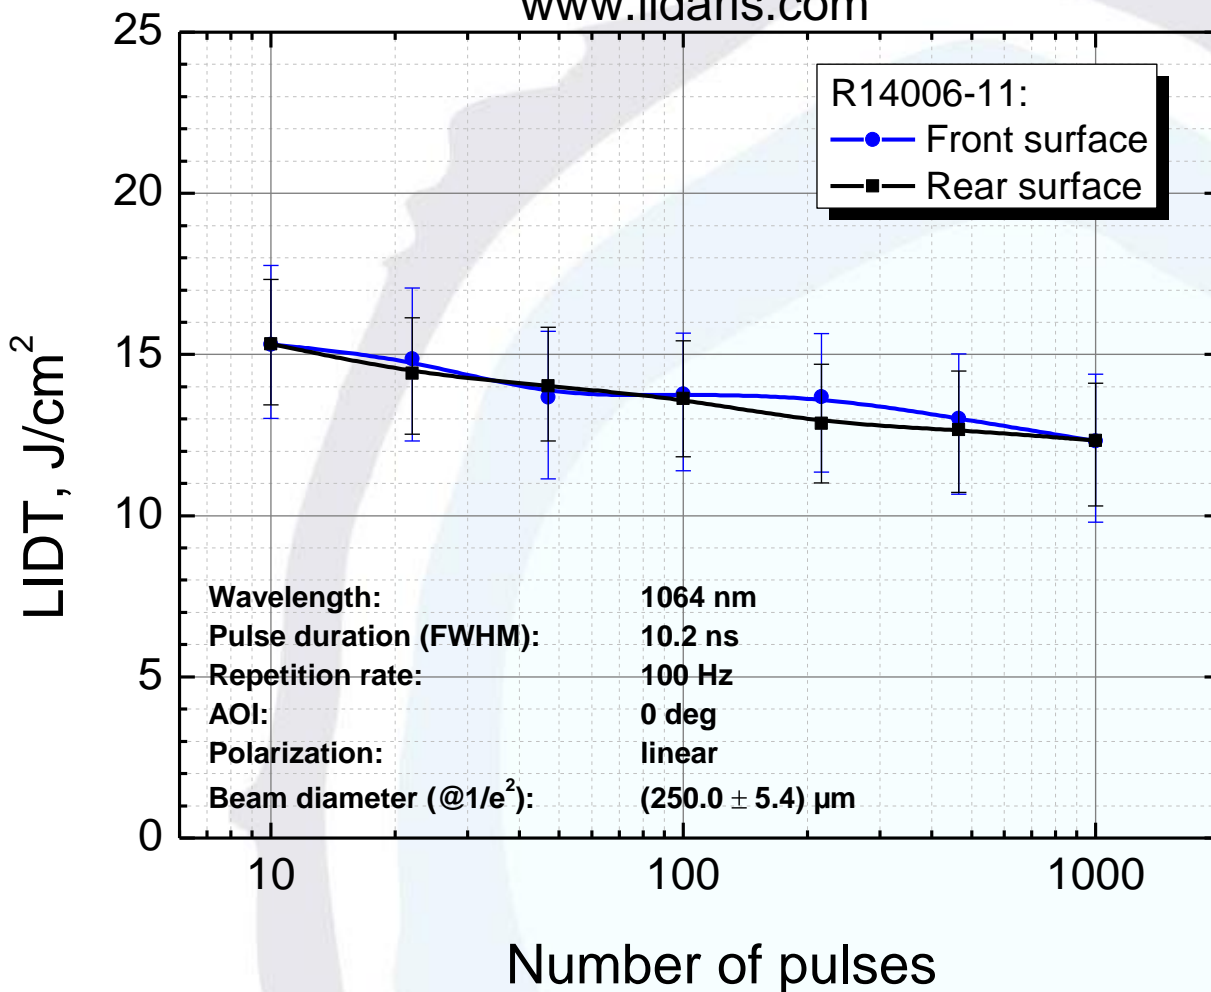
Fig. 2. Characteristic damage curve.

Table 1. Summarized LIDT's for sample R14006-11.

Test mode	Threshold - front surface, J/cm <sup>2</sup>	Threshold - rear surface, J/cm <sup>2</sup>
10-on-1	13.02 ≤ 15.31 ≤ 17.77	13.44 ≤ 15.33 ≤ 17.33
1000-on-1	9.80 ≤ 12.32 ≤ 14.38	10.30 ≤ 12.33 ≤ 14.11

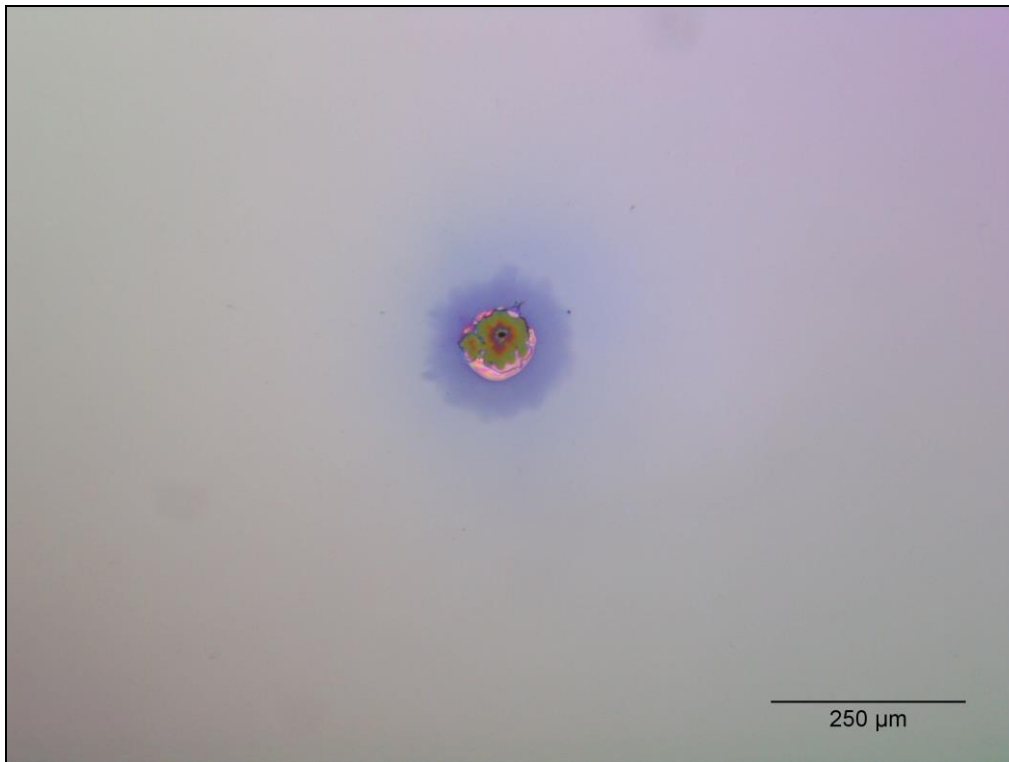
**Fig. 3. Typical front surface damage morphology  
(Energy density 27.54 J/cm<sup>2</sup>, damage after 12 pulses)**

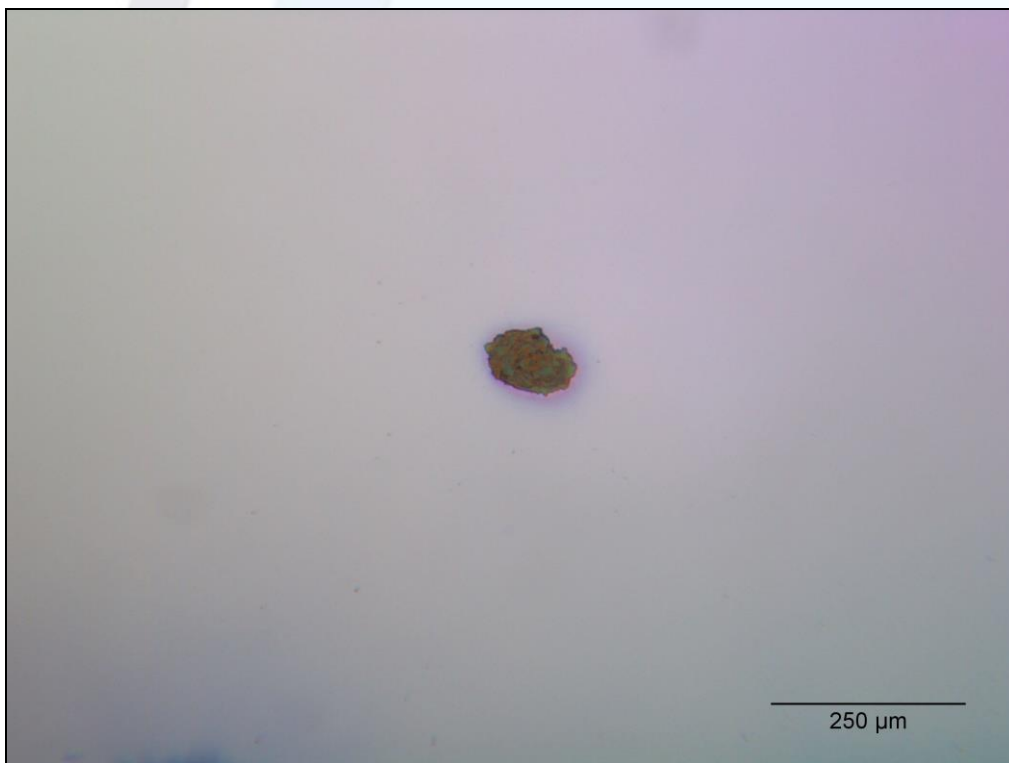
**Fig. 4. Typical front surface damage morphology  
(Energy density 14.24 J/cm<sup>2</sup>, damage after 1000 pulses)**

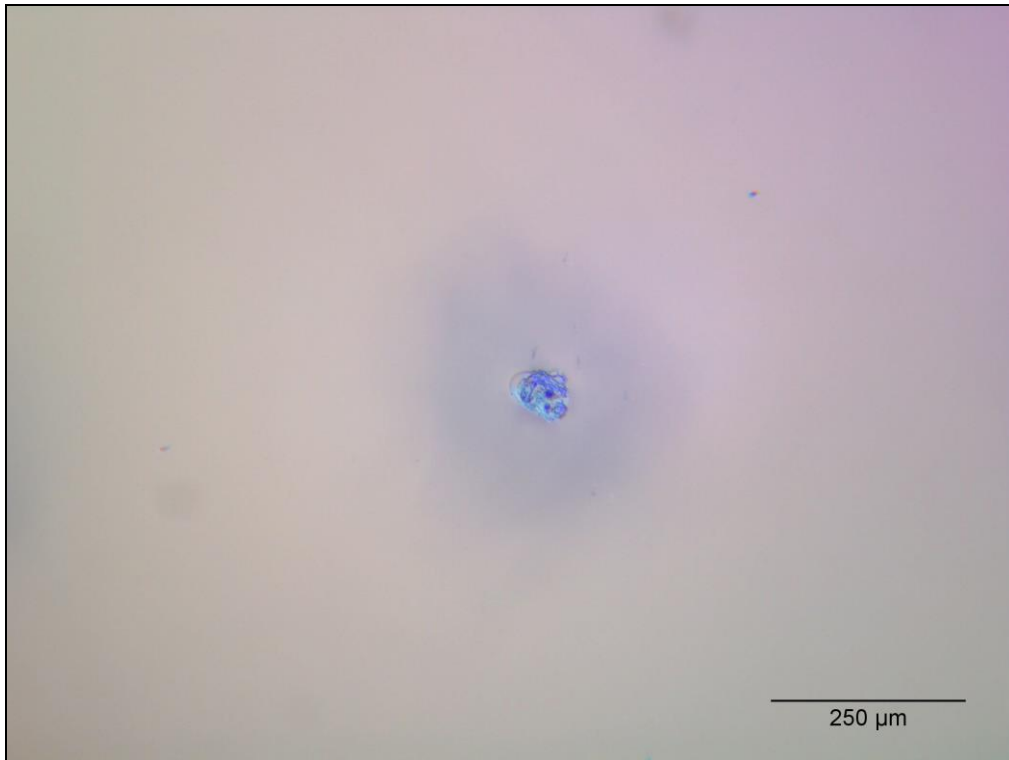
Fig. 5. Typical rear surface damage morphology  
(Energy density  $30.48 \text{ J/cm}^2$ , damage after 10 pulse)

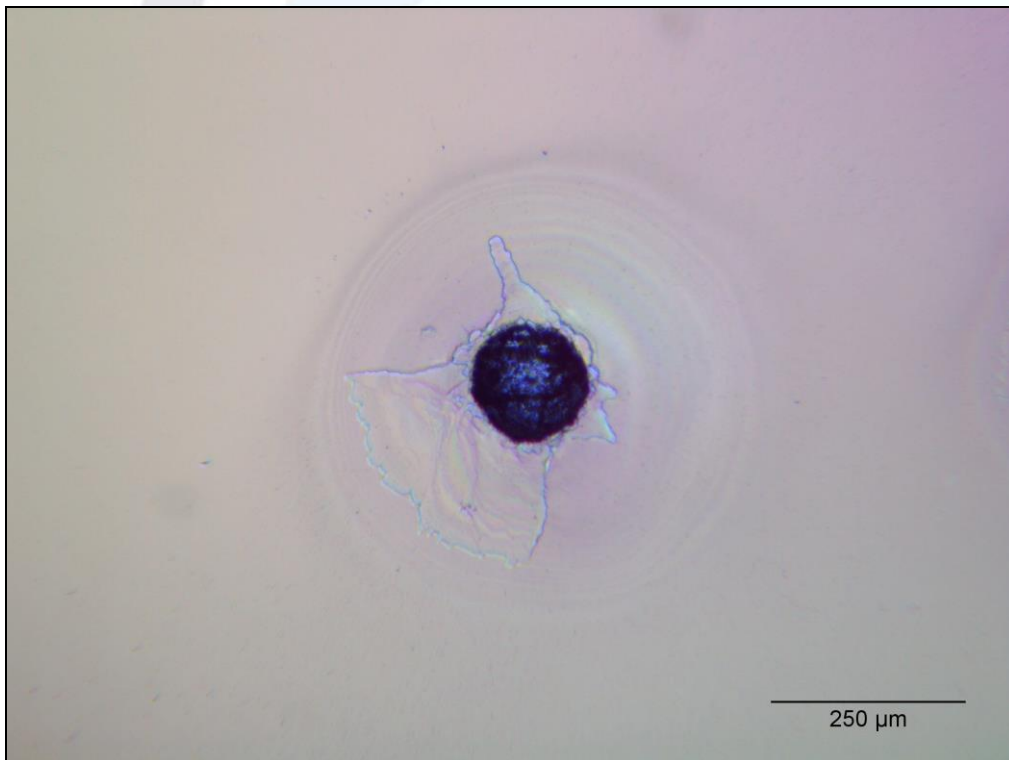
Fig. 6. Typical rear surface damage morphology  
(Energy density  $14.28 \text{ J/cm}^2$ , damage after 1000 pulses)
