Laser-Induced Damage Threshold (LIDT) Measurement Report

ISO21254-2: S-on-1 Test Procedure

Sample: R14006-12

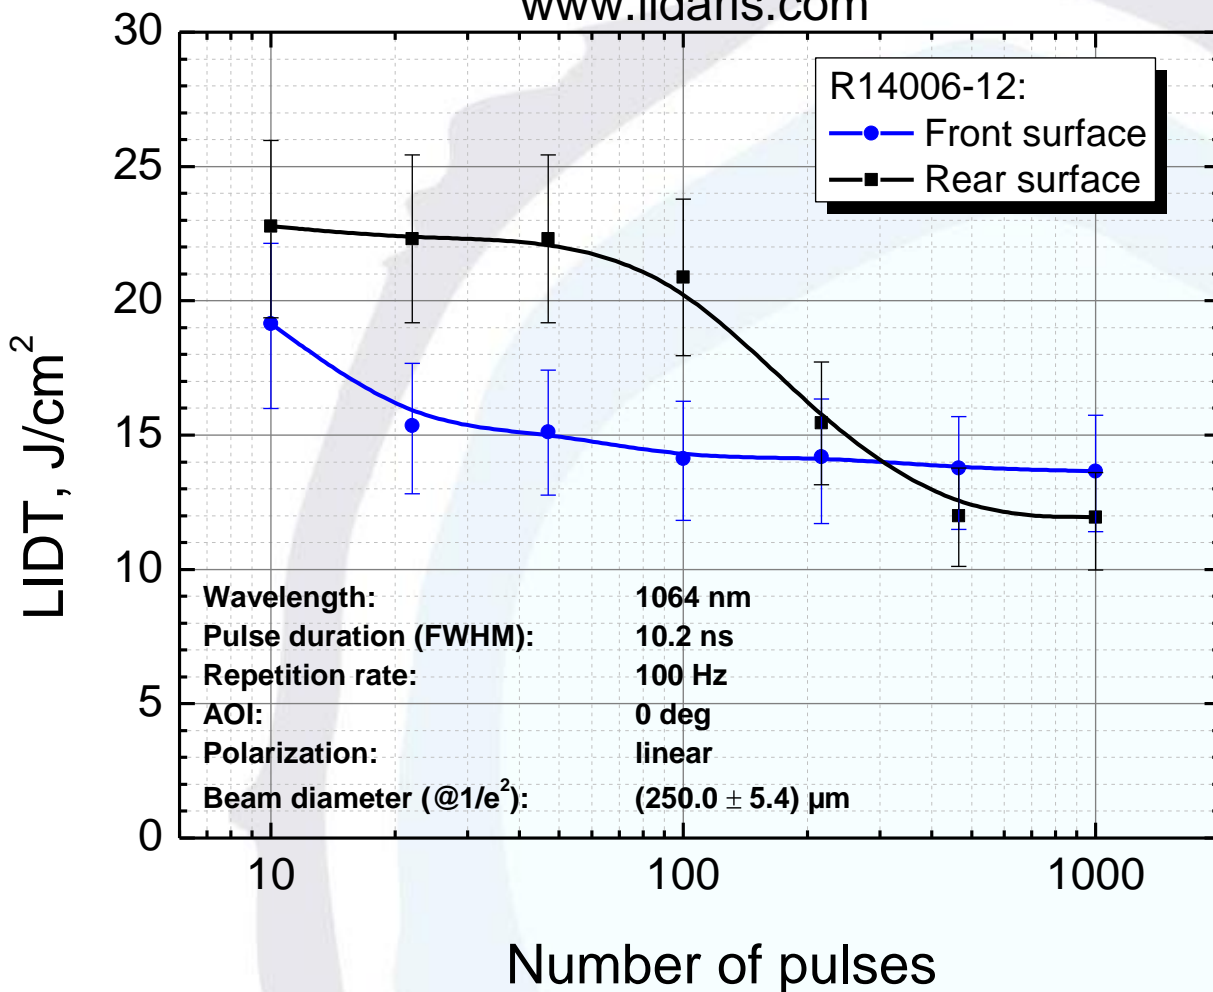
Fig. 2. Characteristic damage curve.

Test mode	Threshold - front surface, J/cm ²	Threshold - rear surface, J/cm ²
10-on-1	15.98 ≤ 19.15 ≤ 22.14	19.36 ≤ 22.77 ≤ 25.96
1000-on-1	11.40 ≤ 13.66 ≤ 15.73	9.98 ≤ 11.94 ≤ 13.61

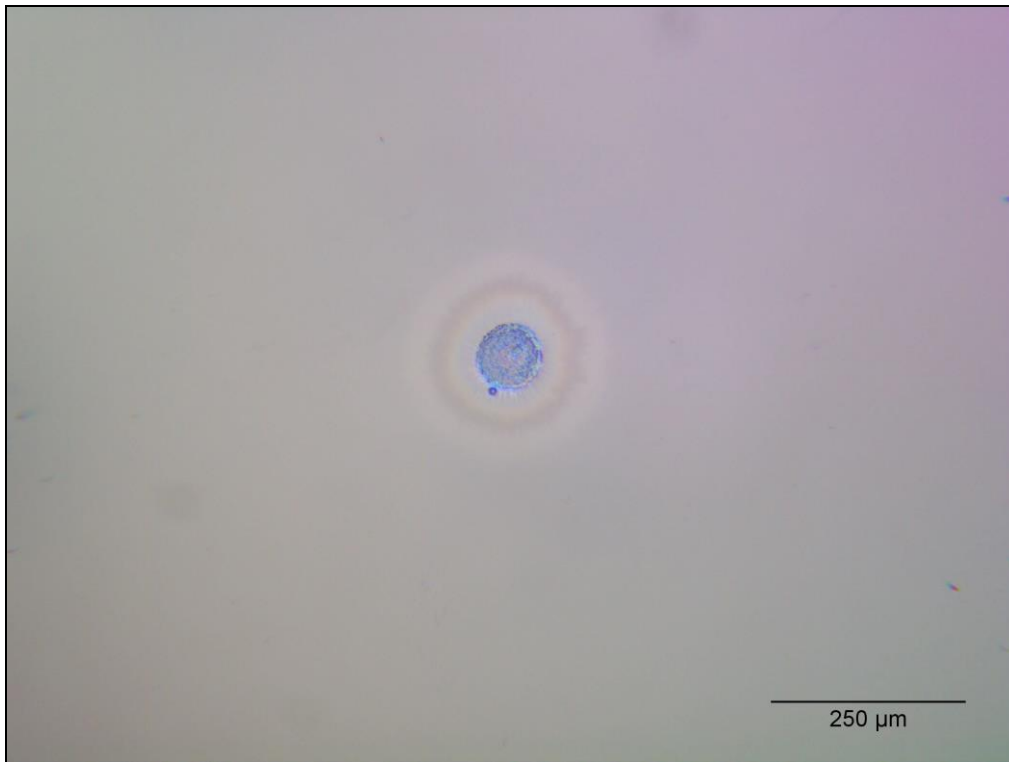
**Fig. 3. Typical front surface damage morphology
(Energy density 30.42 J/cm², damage after 11 pulses)**

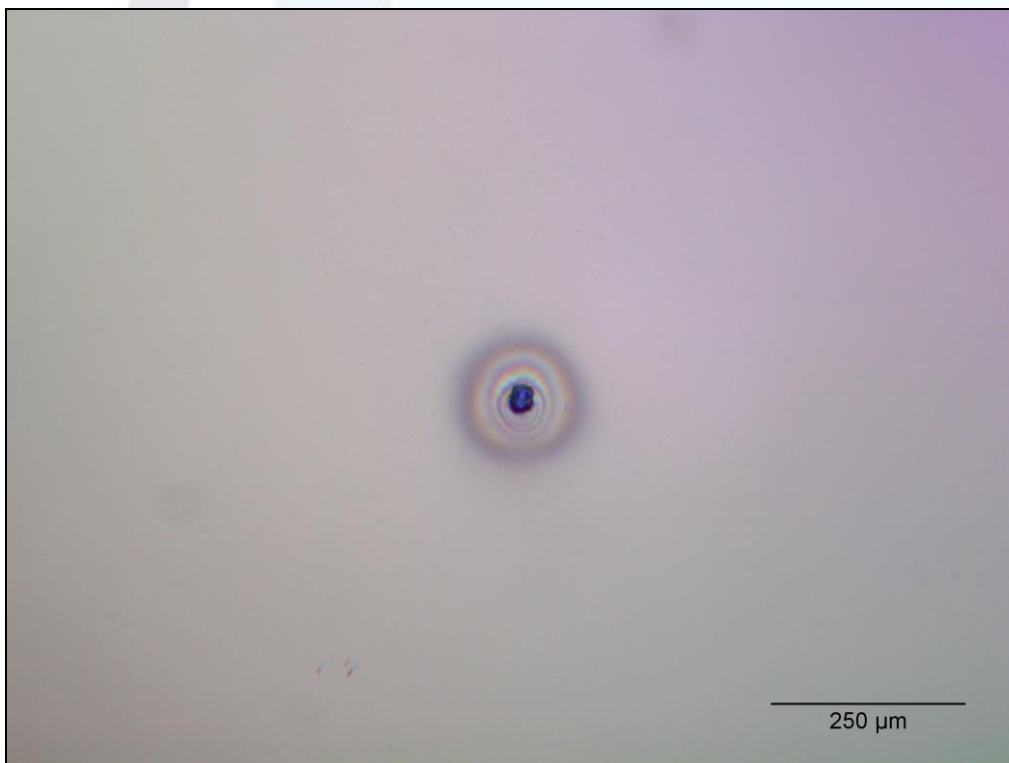
**Fig. 4. Typical front surface damage morphology
(Energy density 15.06 J/cm², damage after 602 pulses)**

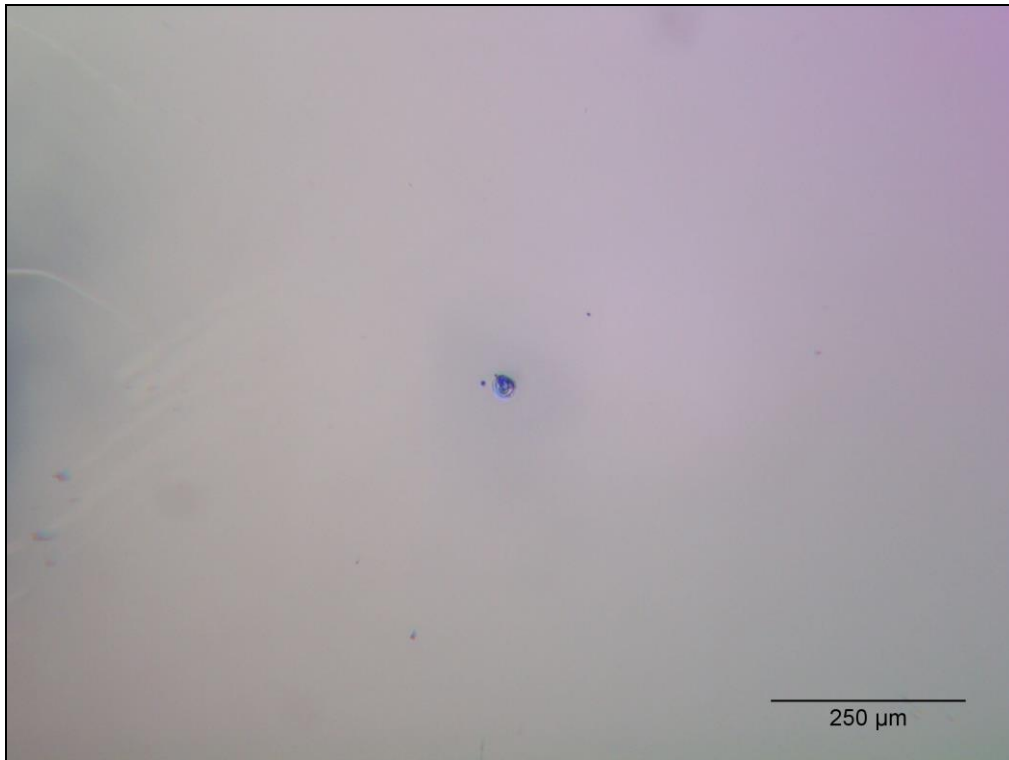
Fig. 5. Typical rear surface damage morphology
(Energy density 30.42 J/cm², damage after 11 pulses)

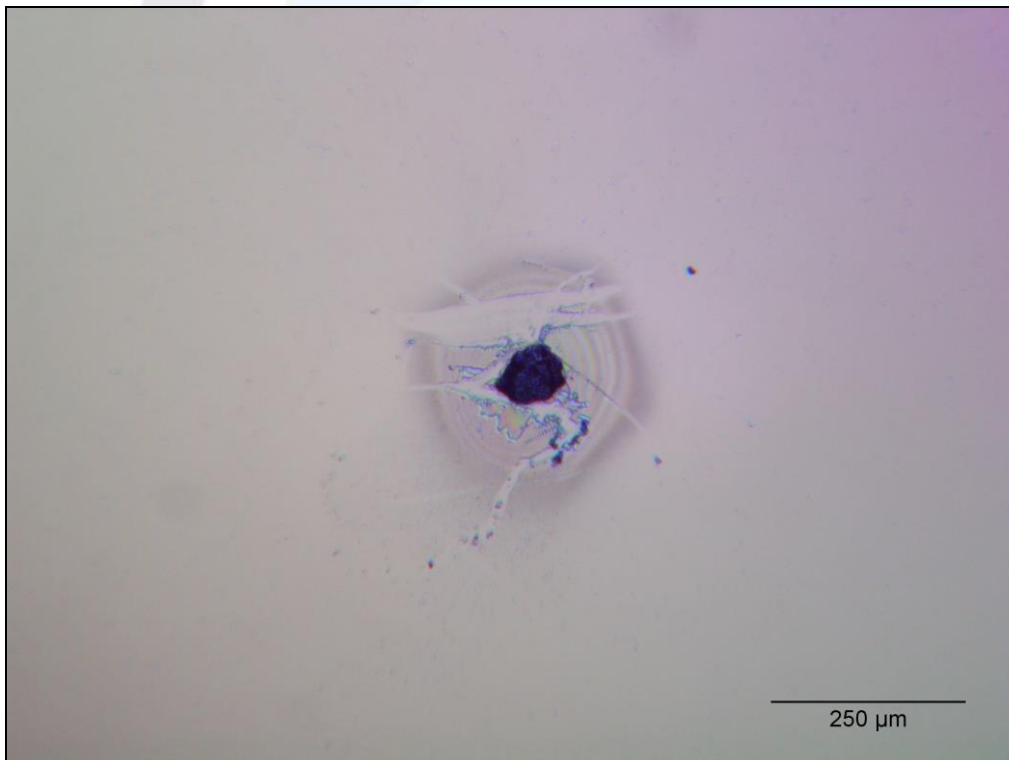
Fig. 6. Typical rear surface damage morphology
(Energy density 12.40 J/cm², damage after 1000 pulses)
