Laser-Induced Damage Threshold (LIDT) Measurement Report

ISO21254-2: S-on-1 Test Procedure

Sample: R14006-8

Lidaris Ltd.
Saulėtekio al. 10,
LT-10223, Vilnius, Lithuania, EU

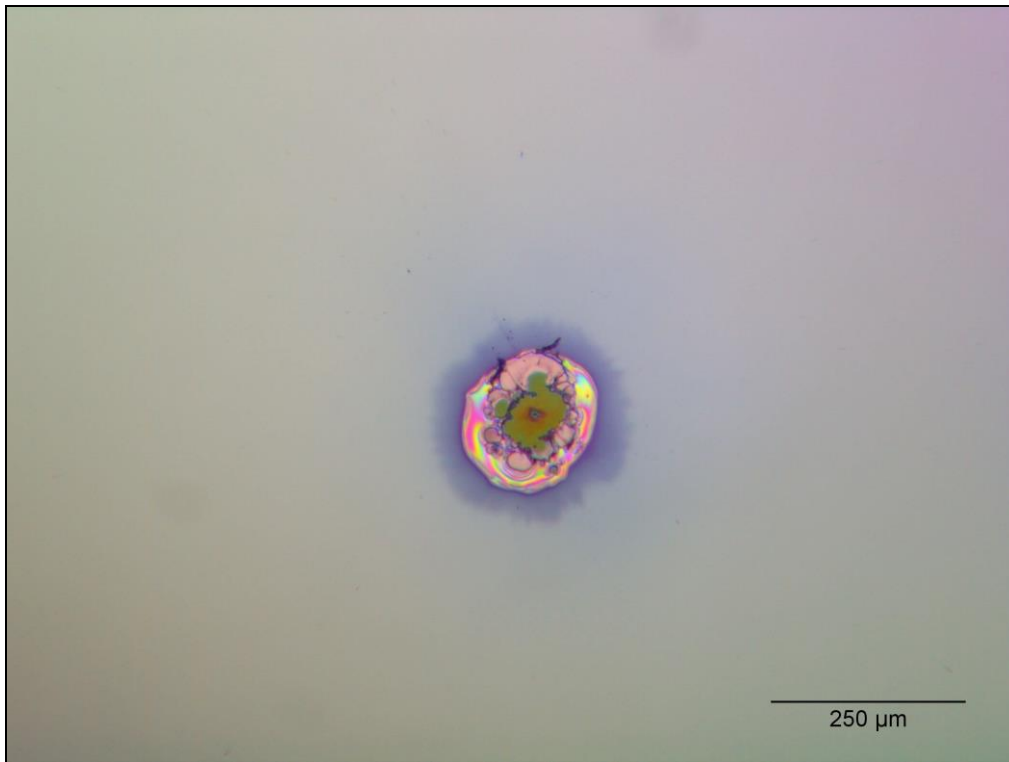
**Fig. 3. Typical front surface damage morphology
(Energy density 30.41 J/cm^2 , damage after 8 pulses)**

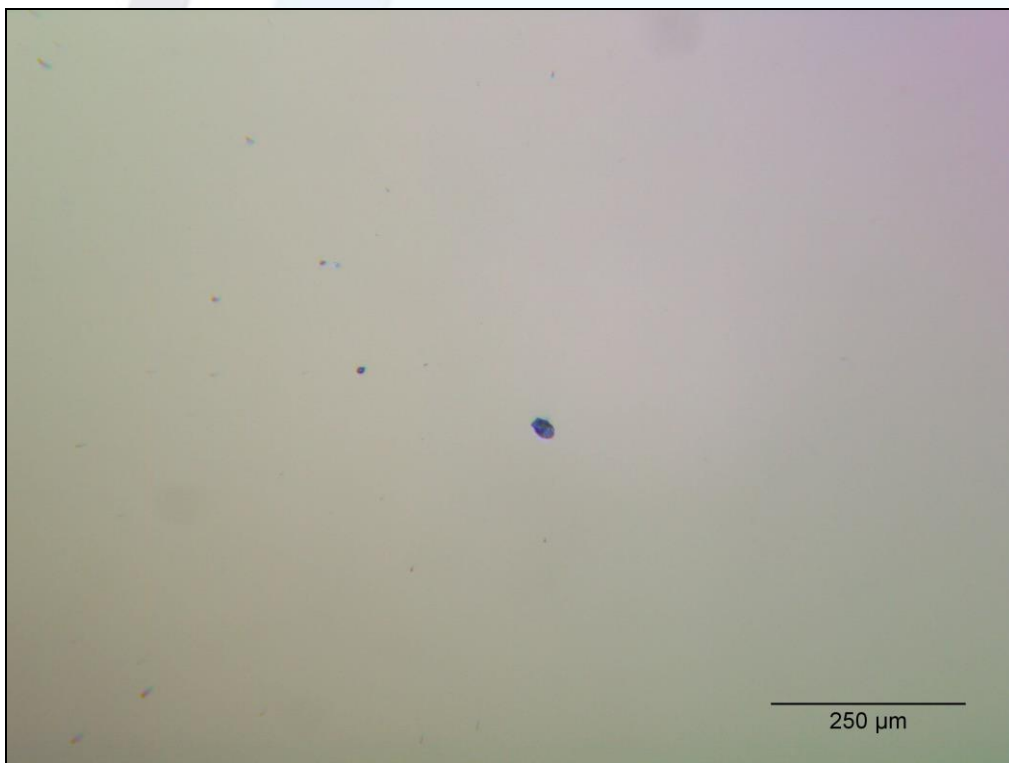
**Fig. 4. Typical front surface damage morphology
(Energy density 7.98 J/cm^2 , damage after 1000 pulses)**

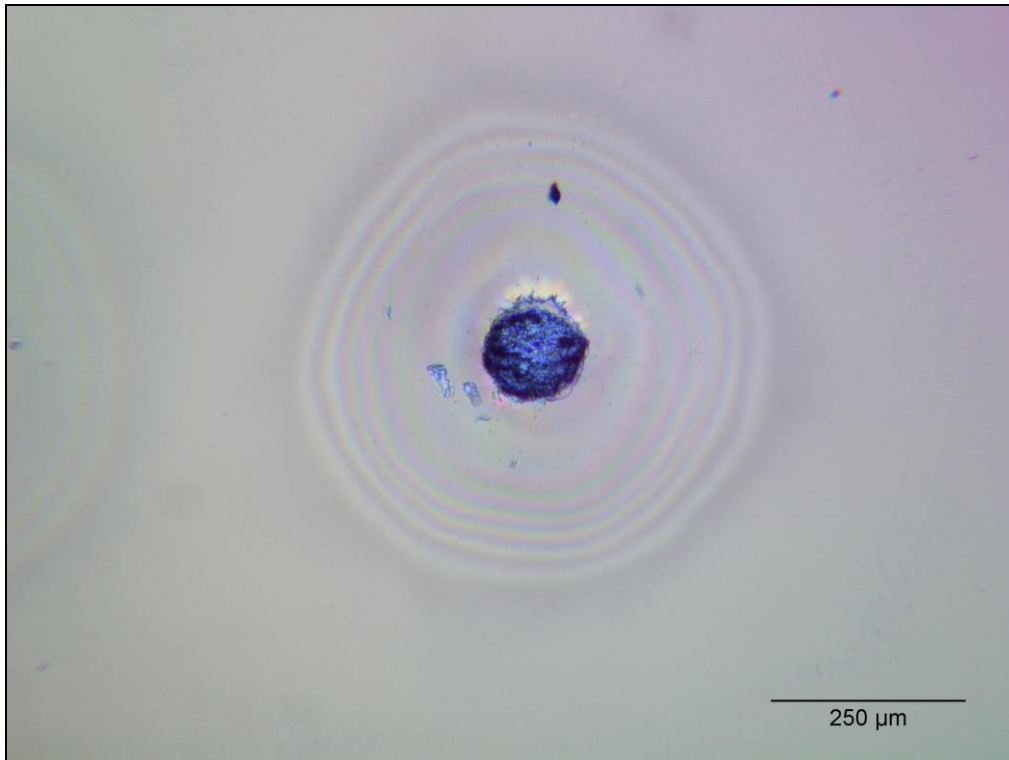
Fig. 5. Typical rear surface damage morphology
(Energy density 30.52 J/cm^2 , damage after 5 pulses)

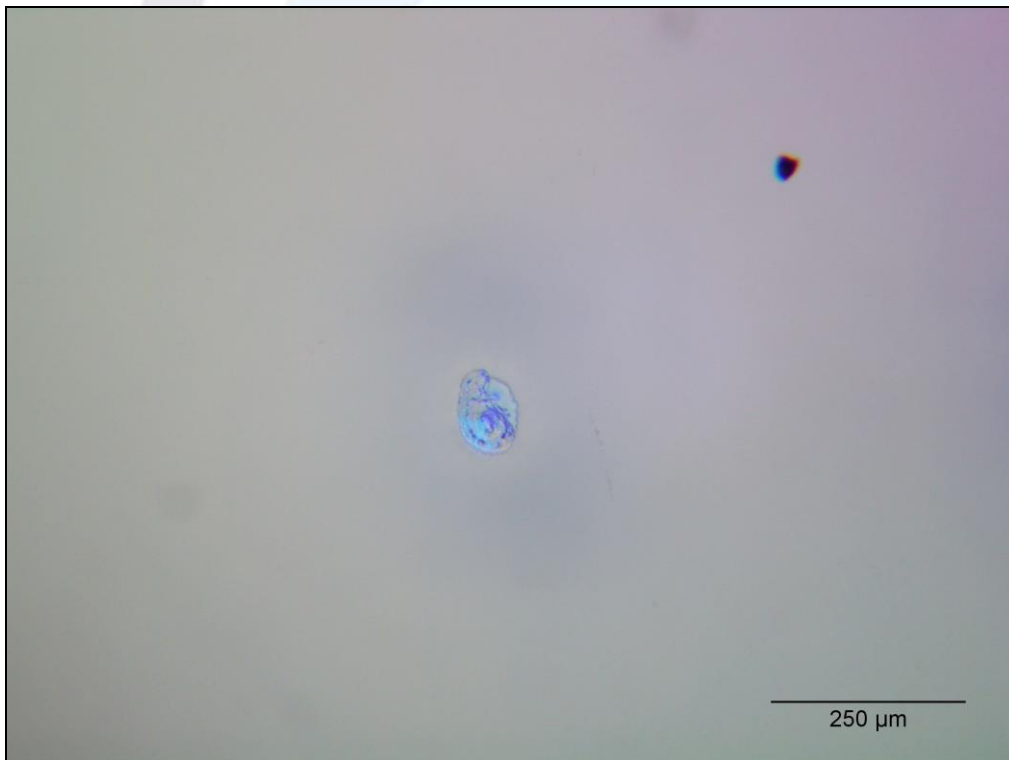
Fig. 6. Typical rear surface damage morphology
(Energy density 18.24 J/cm^2 , damage after 805 pulses)
