Laser-Induced Damage Threshold (LIDT) Measurement Report

ISO21254-2: S-on-1 Test Procedure

Sample: R14006-9

R14006-9

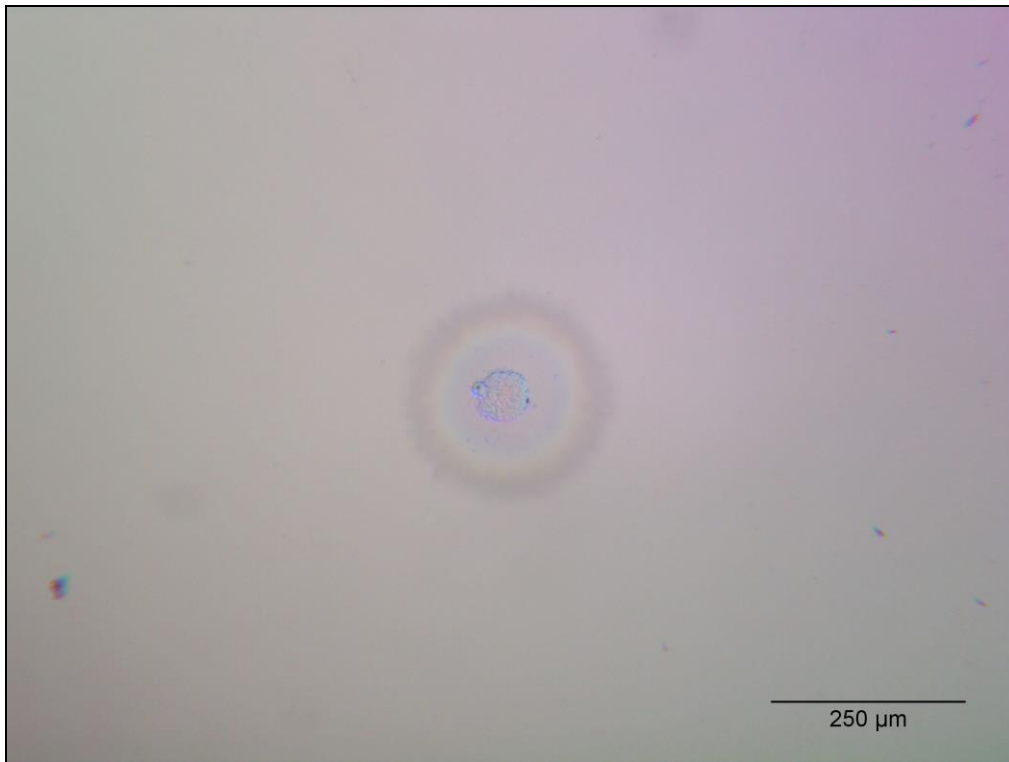
**Fig. 3. Typical front surface damage morphology
(Energy density 40.51 J/cm^2 , damage after 5 pulses)**

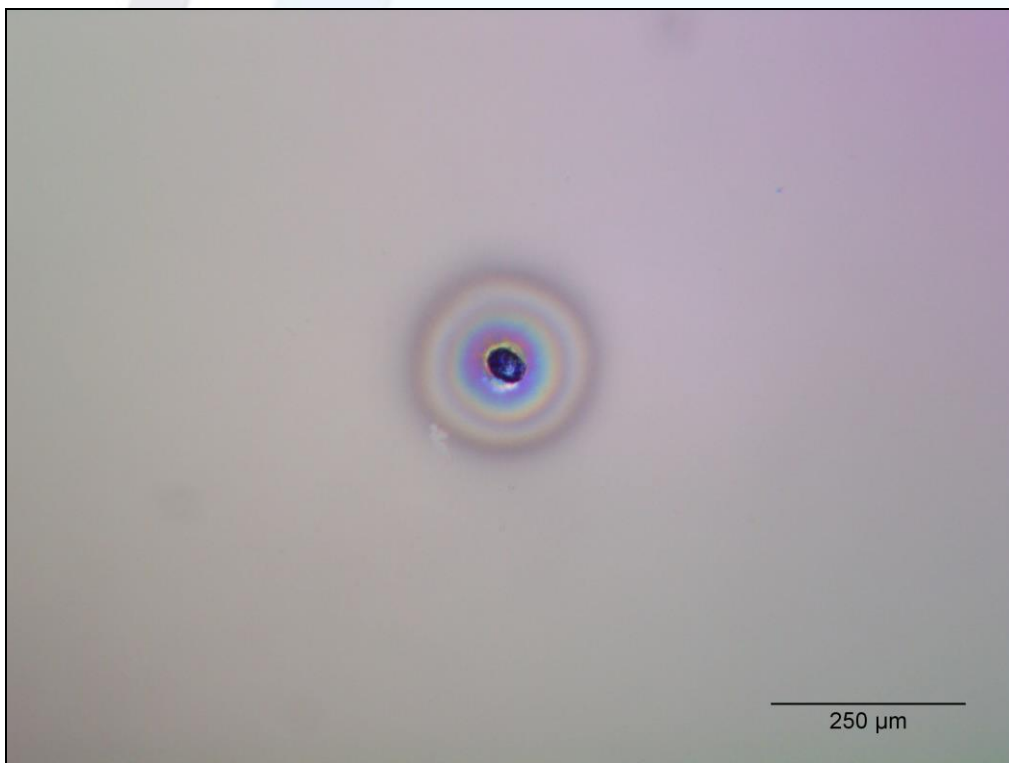
**Fig. 4. Typical front surface damage morphology
(Energy density 15.21 J/cm^2 , damage after 294 pulses)**

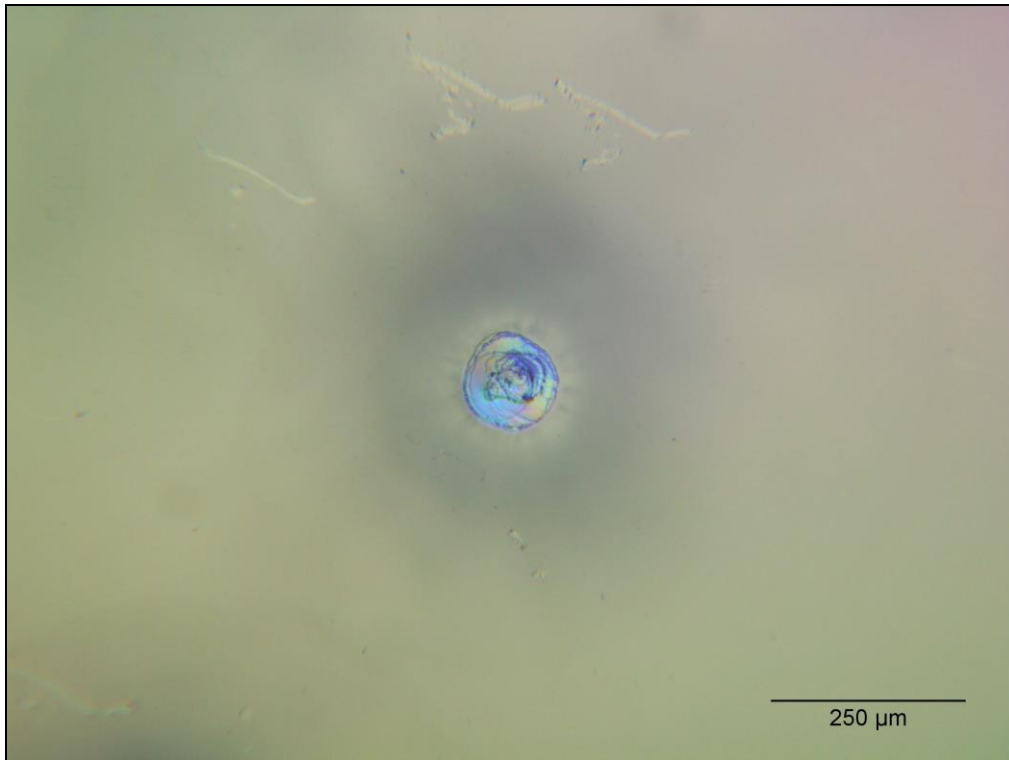
Fig. 5. Typical rear surface damage morphology
(Energy density 49.70 J/cm^2 , damage after 5 pulses)

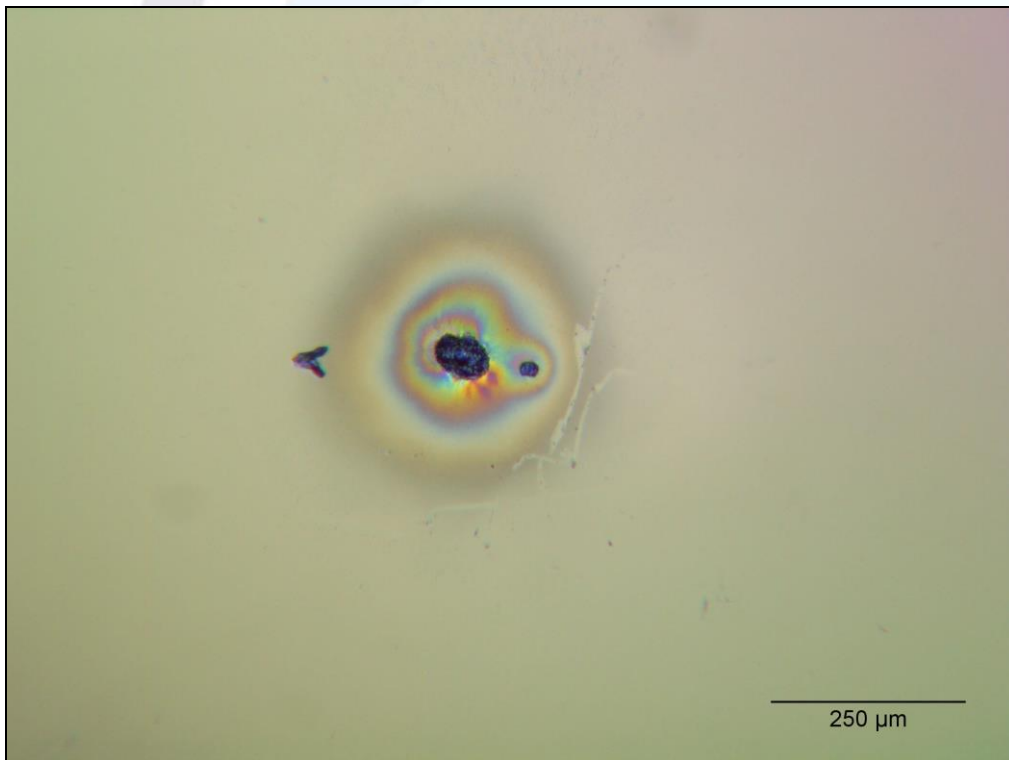
Fig. 6. Typical rear surface damage morphology
(Energy density 17.76 J/cm^2 , damage after 1000 pulses)
