# Assurance of energy handling capability in accordance with ISO 21254-3

## Measurement Report

Sample: R16075-2

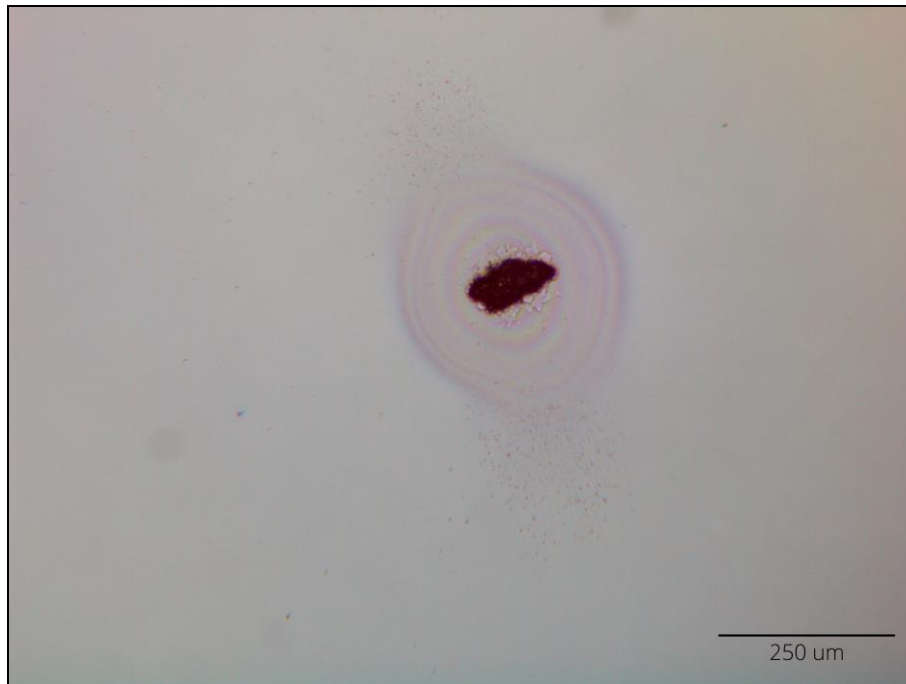
Assurance level	Result
$3.5 \pm 0.6 \text{ J/cm}^2$	Passed
$5.0 \pm 0.9 \text{ J/cm}^2$	Passed
$7.5 \pm 1.1 \text{ J/cm}^2$	Passed
$10.0 \pm 1.4 \text{ J/cm}^2$	Failed

Fig. 3. Typical front surface damage morphology.

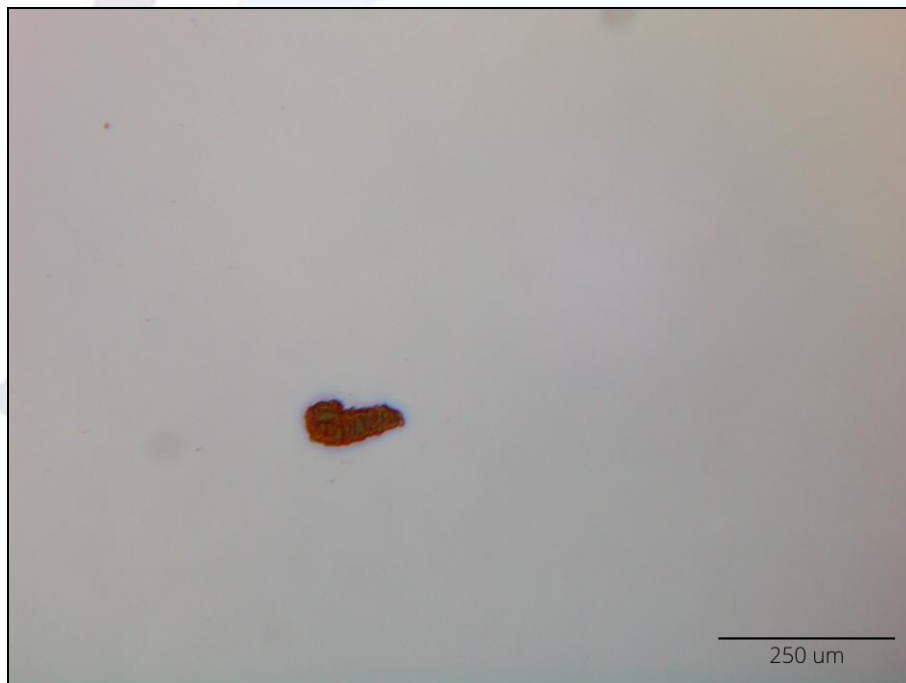
Fig. 4. Typical front surface damage morphology.
