# Laser-Induced Damage Threshold (LIDT) Measurement Report

## ISO21254-2: S-on-1 Test Procedure

Sample: R14006-14

Lidaris Ltd.  
Saulėtekio al. 10,  
LT-10223, Vilnius, Lithuania, EU

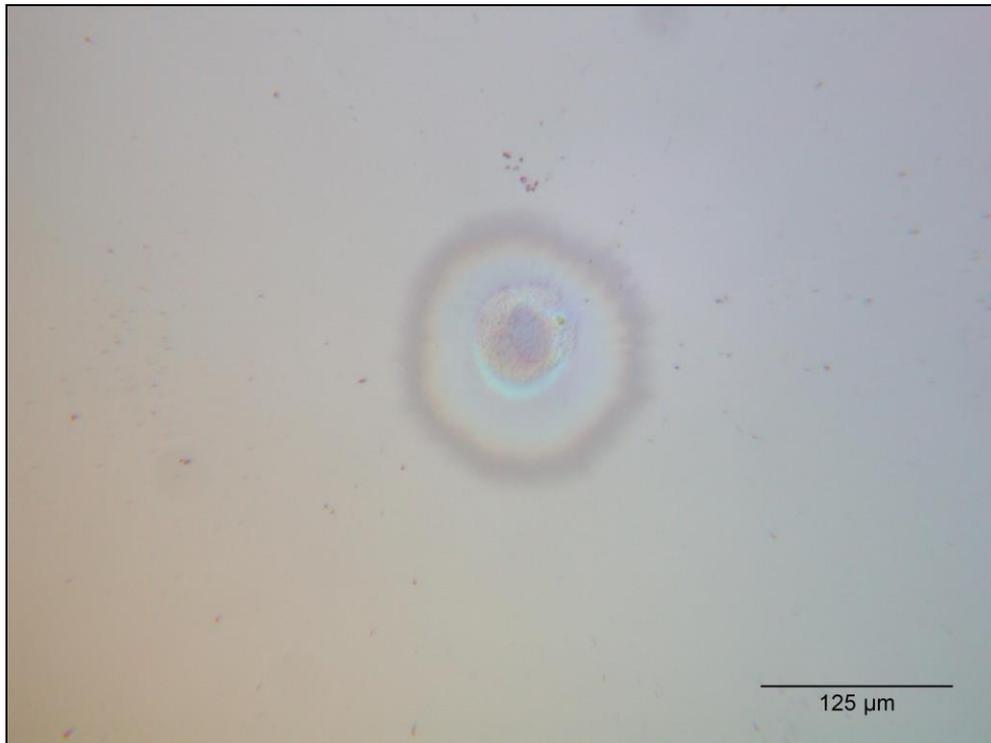
Fig. 3. Typical front surface damage morphology  
(Energy density  $27.64 \text{ J/cm}^2$ , damage after 2 pulses)

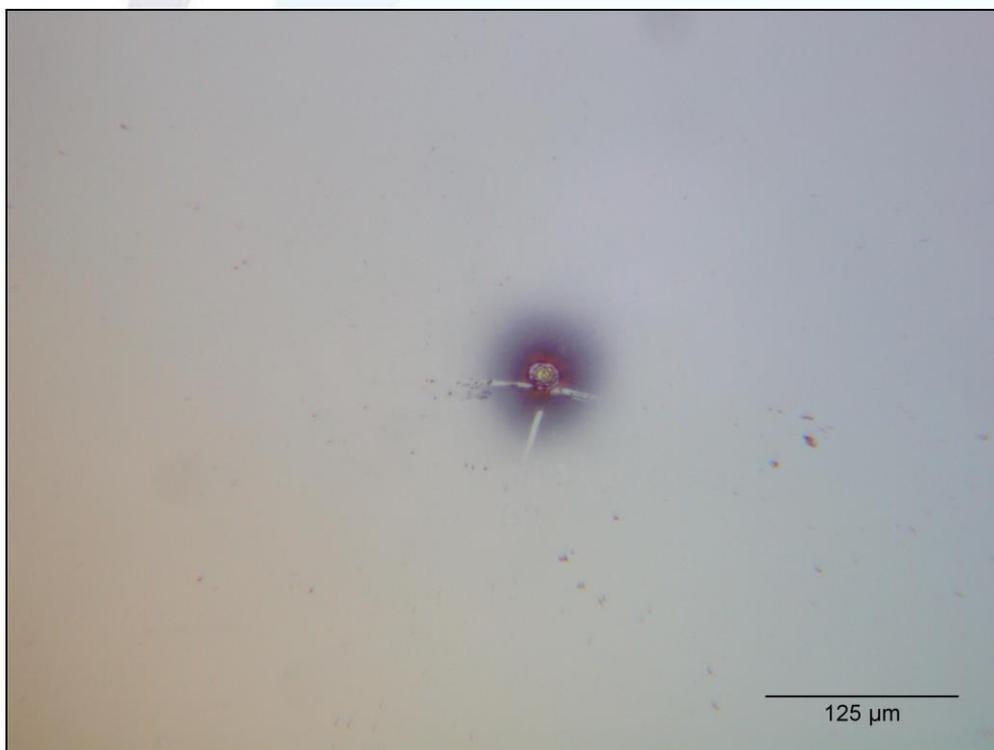
Fig. 4. Typical front surface damage morphology  
(Energy density  $12.92 \text{ J/cm}^2$ , damage after 34 pulses)

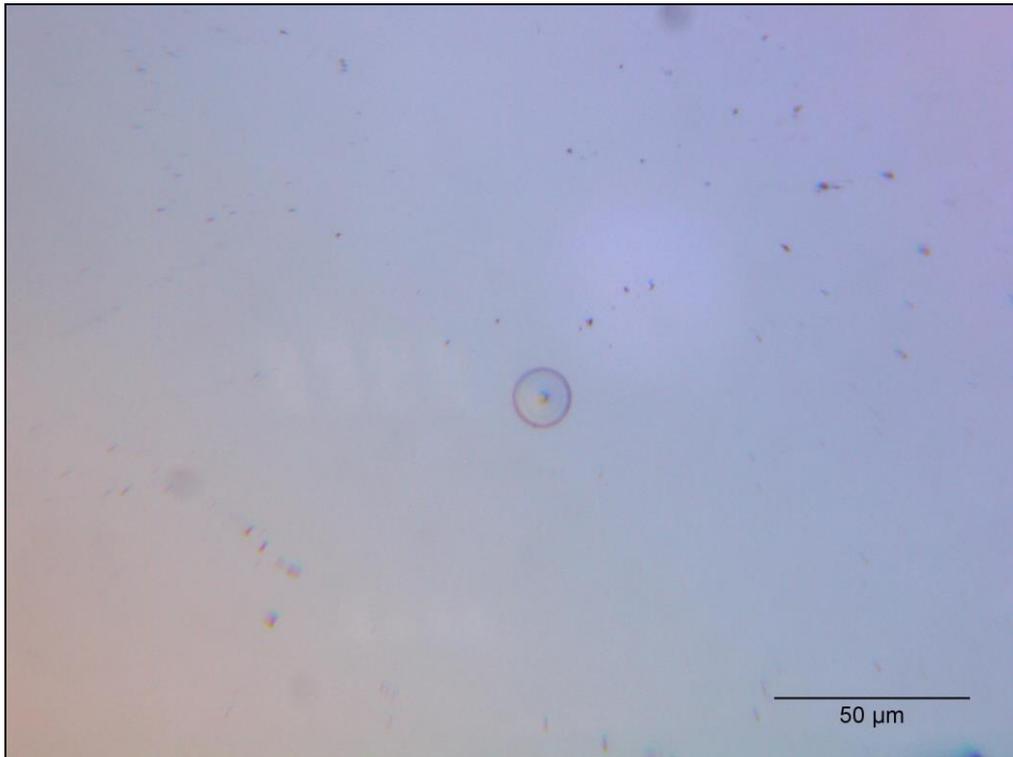
Fig. 5. Typical back surface damage morphology  
(Energy density  $33.14 \text{ J/cm}^2$ , damage after 1 pulse)

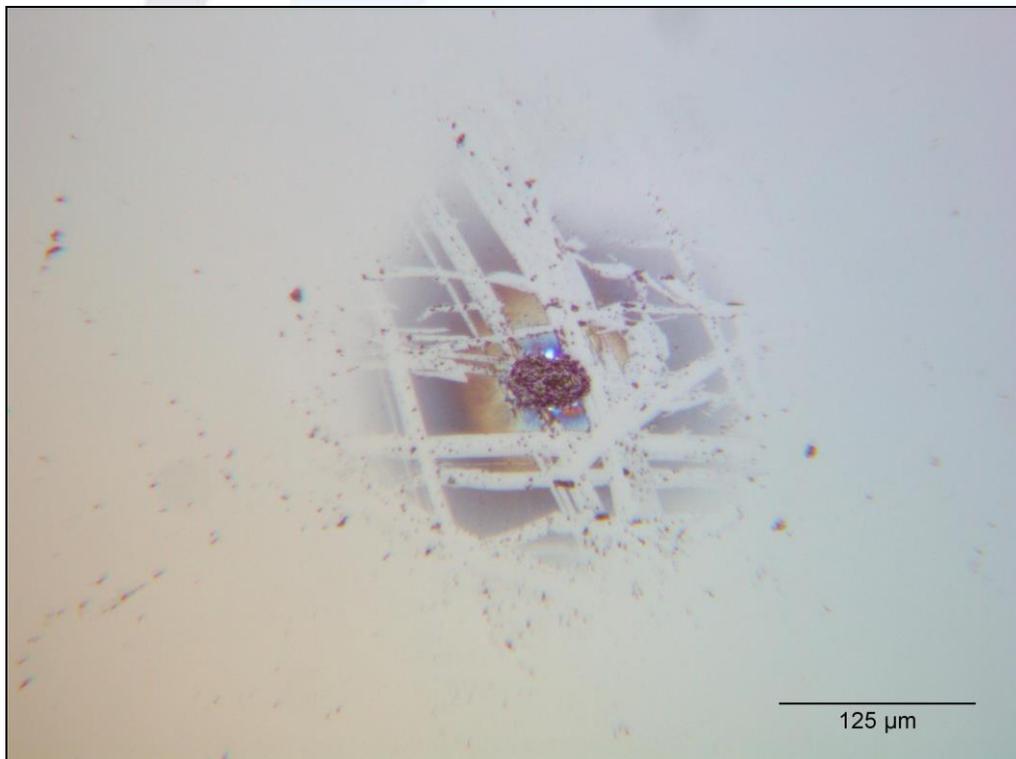
Fig. 6. Typical back surface damage morphology  
(Energy density  $15.65 \text{ J/cm}^2$ , damage after 91 pulses)
