Laser-Induced Damage Threshold (LIDT) Measurement Report

ISO21254-2: S-on-1 Test Procedure

Sample: R14006-13

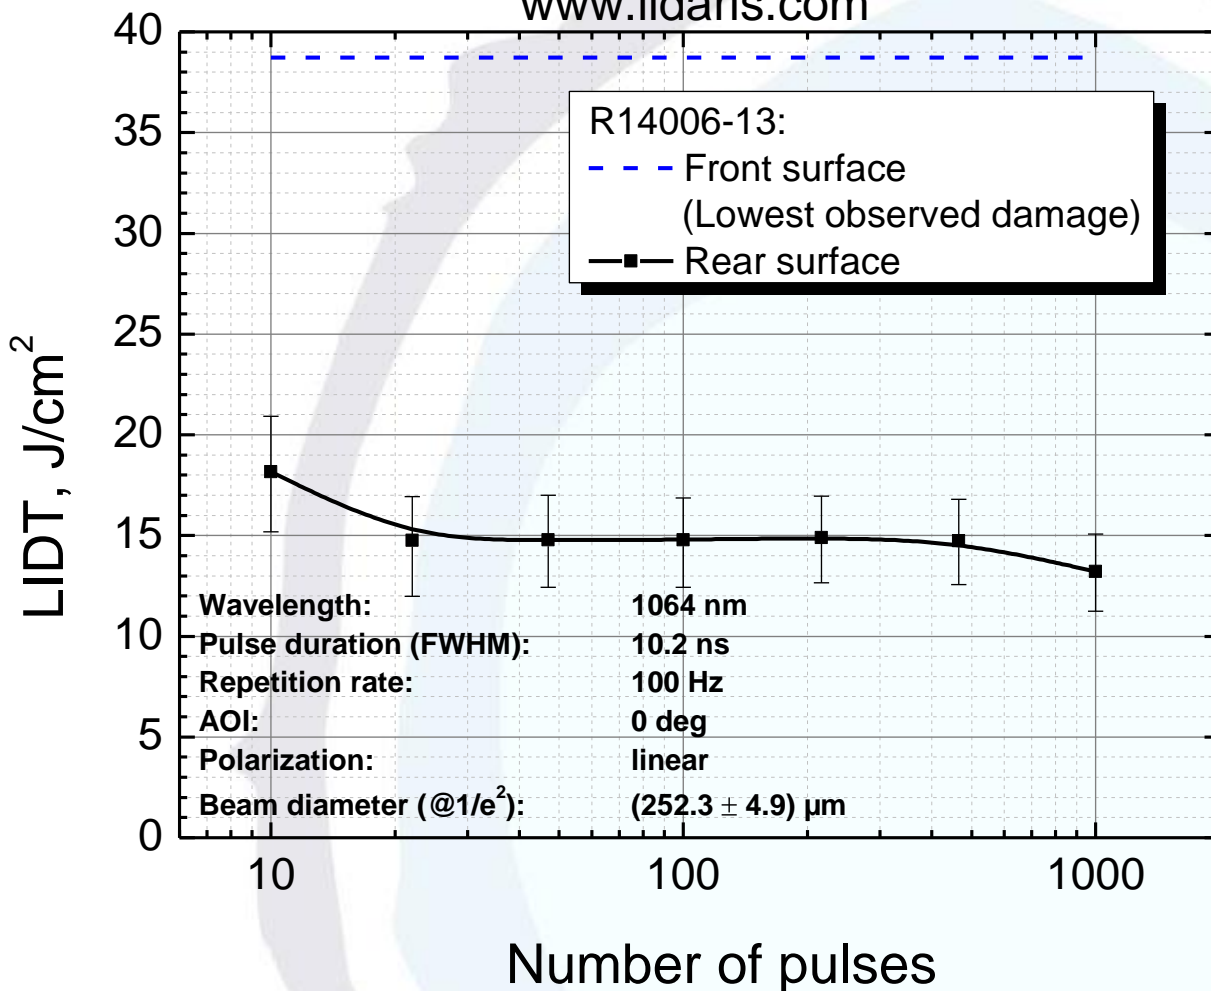
Test mode	Threshold - front surface, J/cm ²	Threshold - rear surface, J/cm ²
10-on-1	Insufficient data. (See technical note)	15.19 ≤ 18.16 ≤ 20.93
1000-on-1	Insufficient data. (See technical note)	11.25 ≤ 13.22 ≤ 15.07

Fig. 2. Characteristic damage curve.

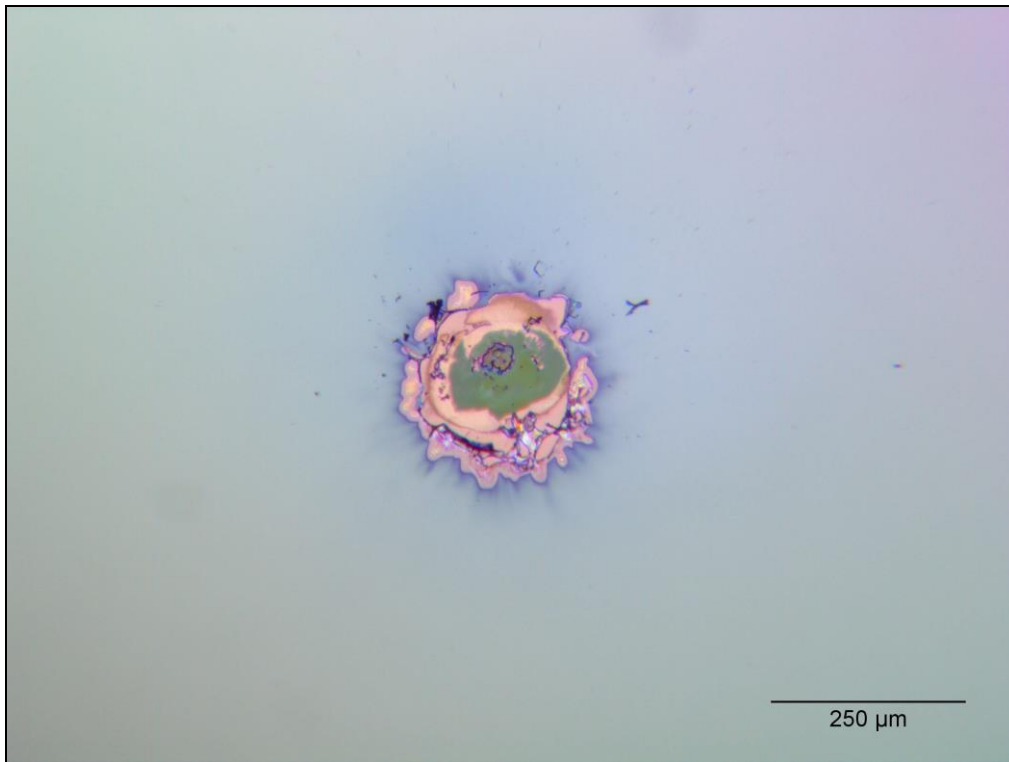
Fig. 3. Typical front surface damage morphology
(Energy density 38.72 J/cm^2 , damage after 9 pulses)

Only 1 site out of 212 was damaged on the front surface, which is not enough to reliably evaluate the LIDT. Lowest observed damage was at 38.72 J/cm^2 after 9 pulses (see Fig. 3.)

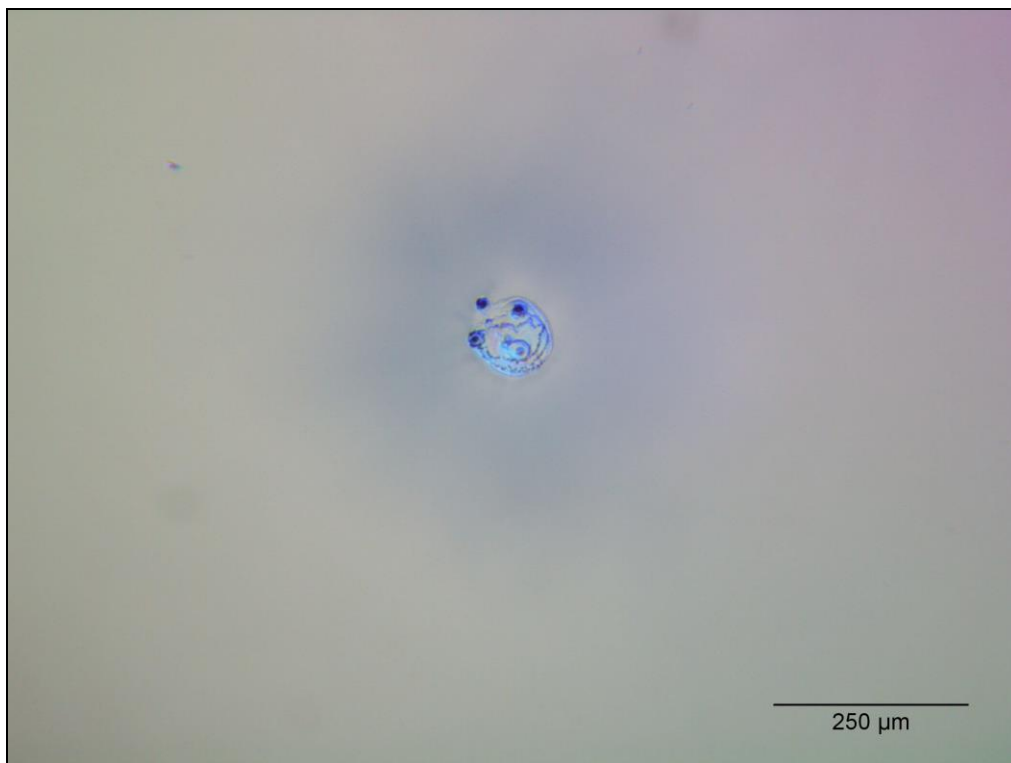
Fig. 4. Typical rear surface damage morphology
(Energy density 32.68 J/cm^2 , damage after 6 pulse)

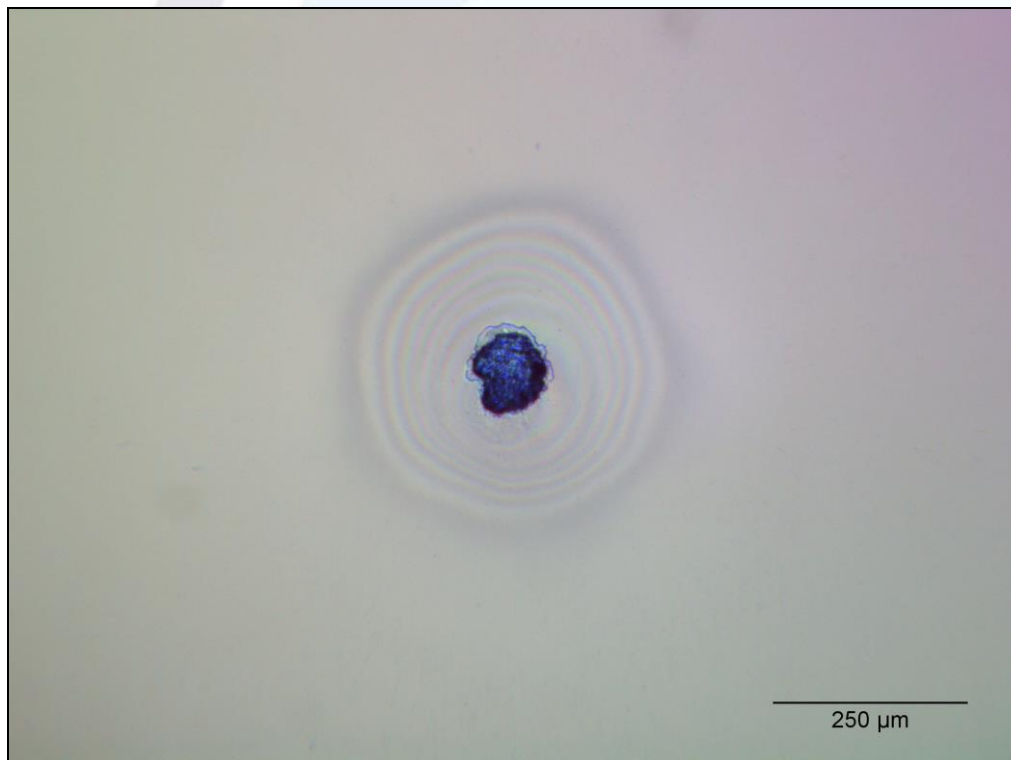
Fig. 5. Typical rear surface damage morphology
(Energy density 16.15 J/cm^2 , damage after 743 pulses)
