# Laser-Induced Damage Threshold (LIDT) Measurement Report

## ISO21254-2: S-on-1 Test Procedure

Sample: R14006-10

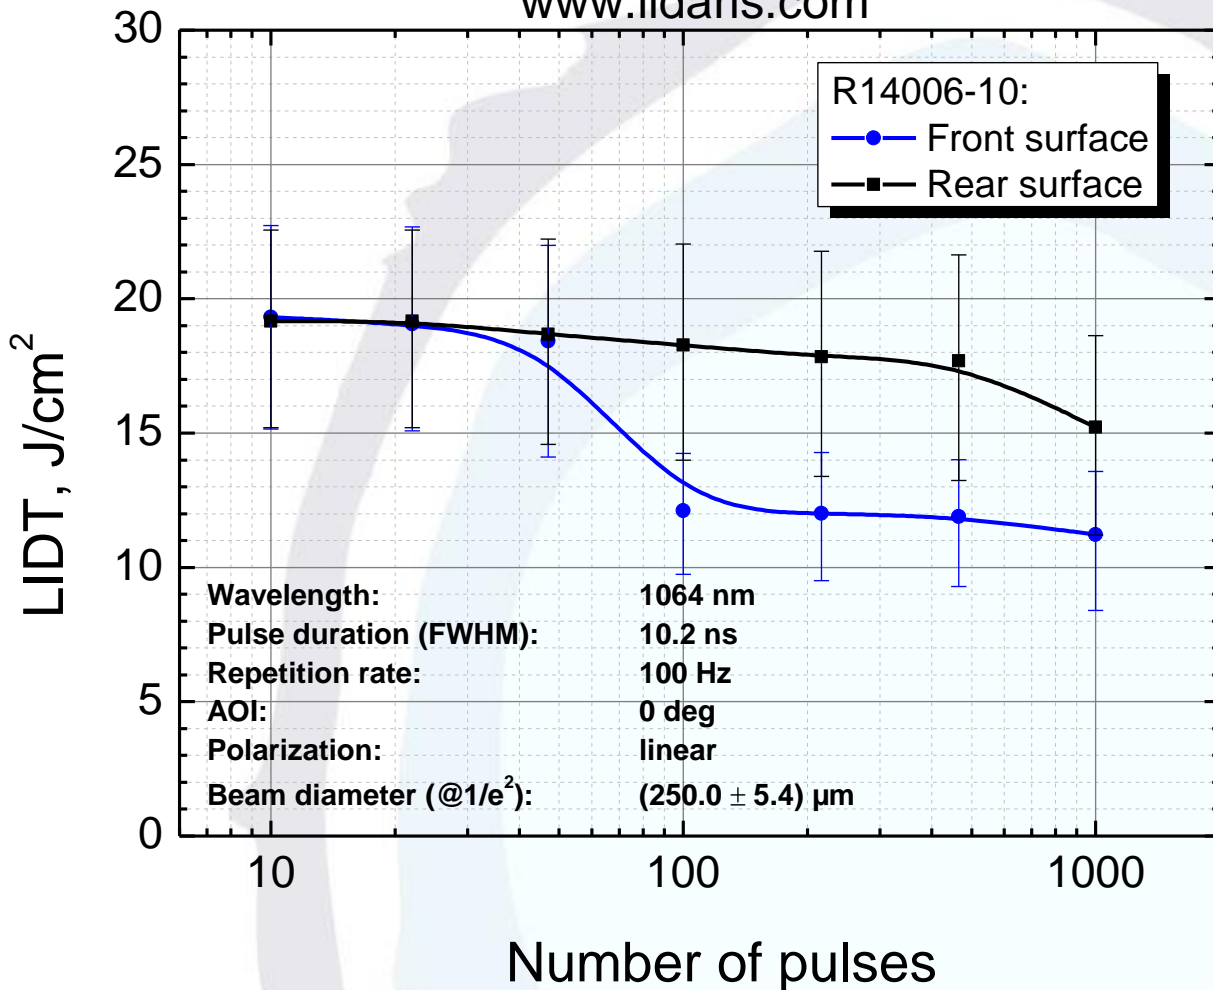
Test mode	Threshold - front surface, J/cm <sup>2</sup>	Threshold - rear surface, J/cm <sup>2</sup>
10-on-1	15.14 ≤ 19.32 ≤ 22.73	15.50 ≤ 19.16 ≤ 22.55
1000-on-1	8.40 ≤ 11.22 ≤ 13.58	11.21 ≤ 15.22 ≤ 18.63

Fig. 2. Characteristic damage curve.
