Laser-Induced Damage Threshold (LIDT) Measurement Report

ISO21254-2: S-on-1 Test Procedure

Sample: R14006-8

Lidaris Ltd.
Saulėtekio al. 10,
LT-10223, Vilnius, Lithuania, EU

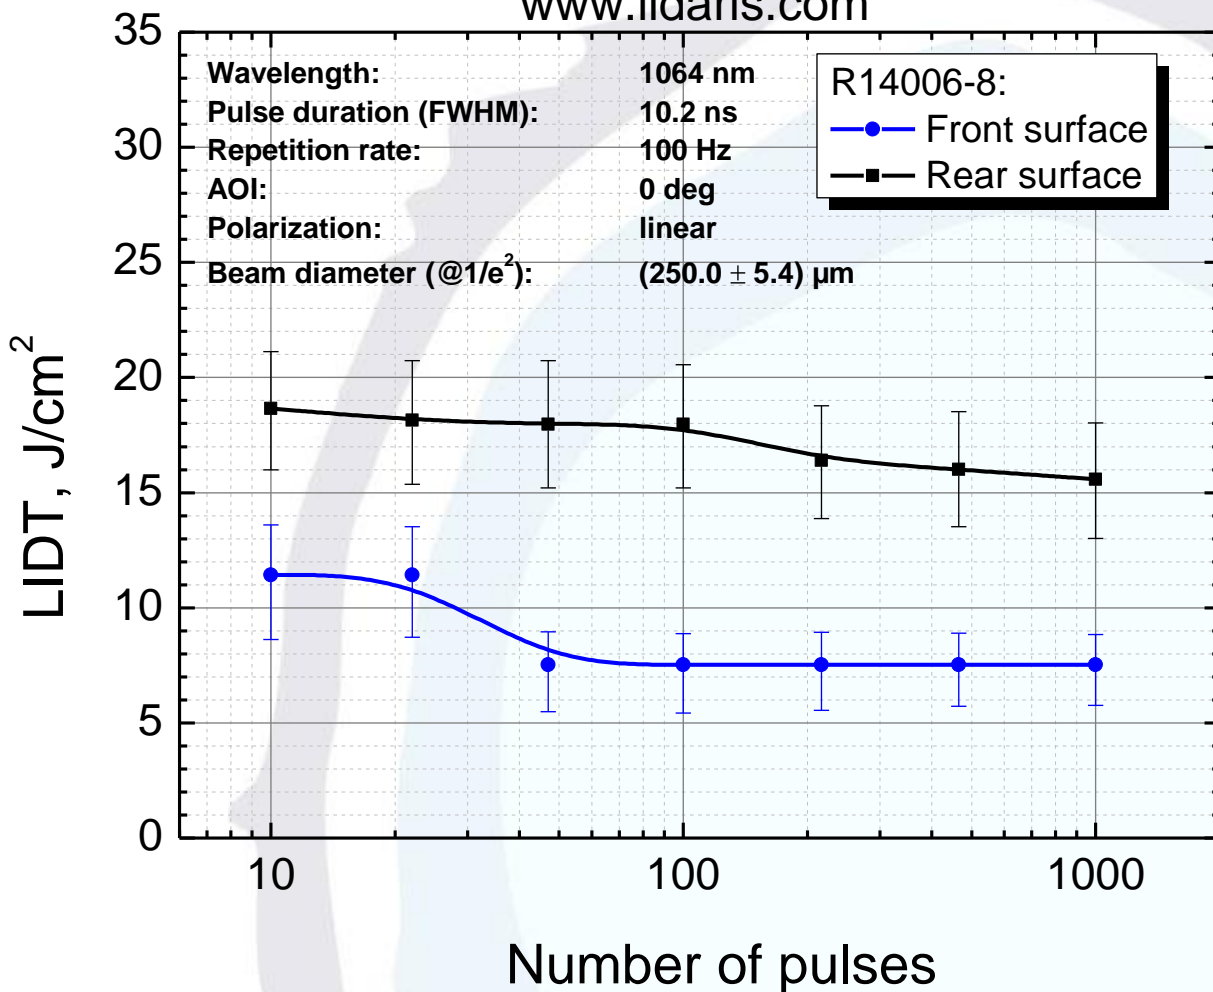
Test mode	Threshold - front surface, J/cm ²	Threshold - rear surface, J/cm ²
10-on-1	8.62 ≤ 11.42 ≤ 13.60	15.99 ≤ 18.65 ≤ 21.12
1000-on-1	5.76 ≤ 7.52 ≤ 8.83	13.01 ≤ 15.59 ≤ 18.02

Fig. 2. Characteristic damage curve.
