Laser-Induced Damage Threshold (LIDT) Measurement Report

ISO21254-2: S-on-1 Test Procedure

Sample: R14006-9

R14006-9

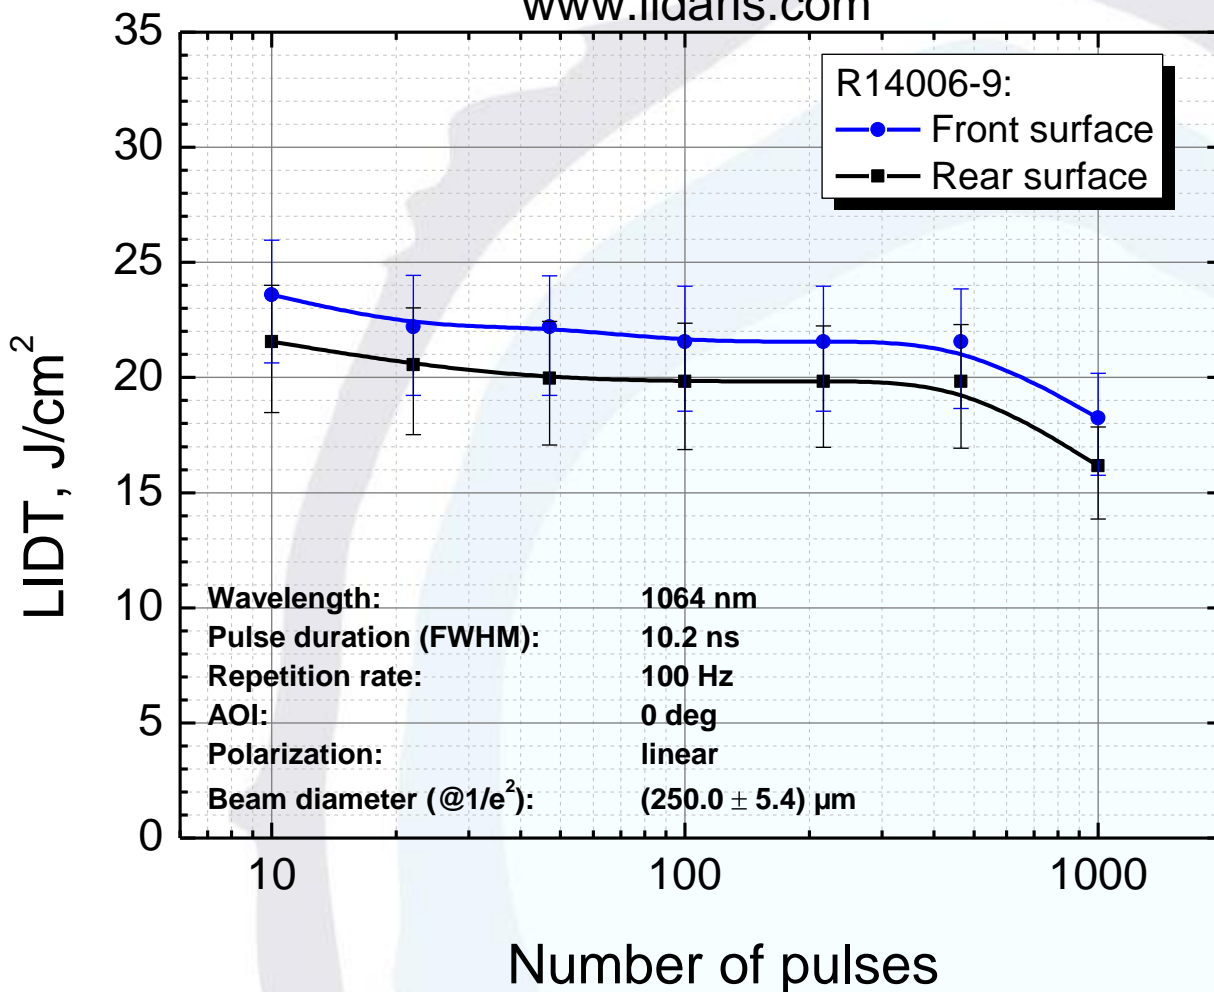
Test mode	Threshold - front surface, J/cm ²	Threshold - rear surface, J/cm ²
10-on-1	20.64 ≤ 23.59 ≤ 25.97	18.94 ≤ 21.56 ≤ 24.02
1000-on-1	15.76 ≤ 18.24 ≤ 20.19	13.85 ≤ 16.17 ≤ 17.85

Fig. 2. Characteristic damage curve.
