# Laser-Induced Damage Threshold (LIDT) Measurement Report

## ISO21254-2: S-on-1 Test Procedure

Sample: R14006-14

Lidaris Ltd.  
Saulėtekio al. 10,  
LT-10223, Vilnius, Lithuania, EU

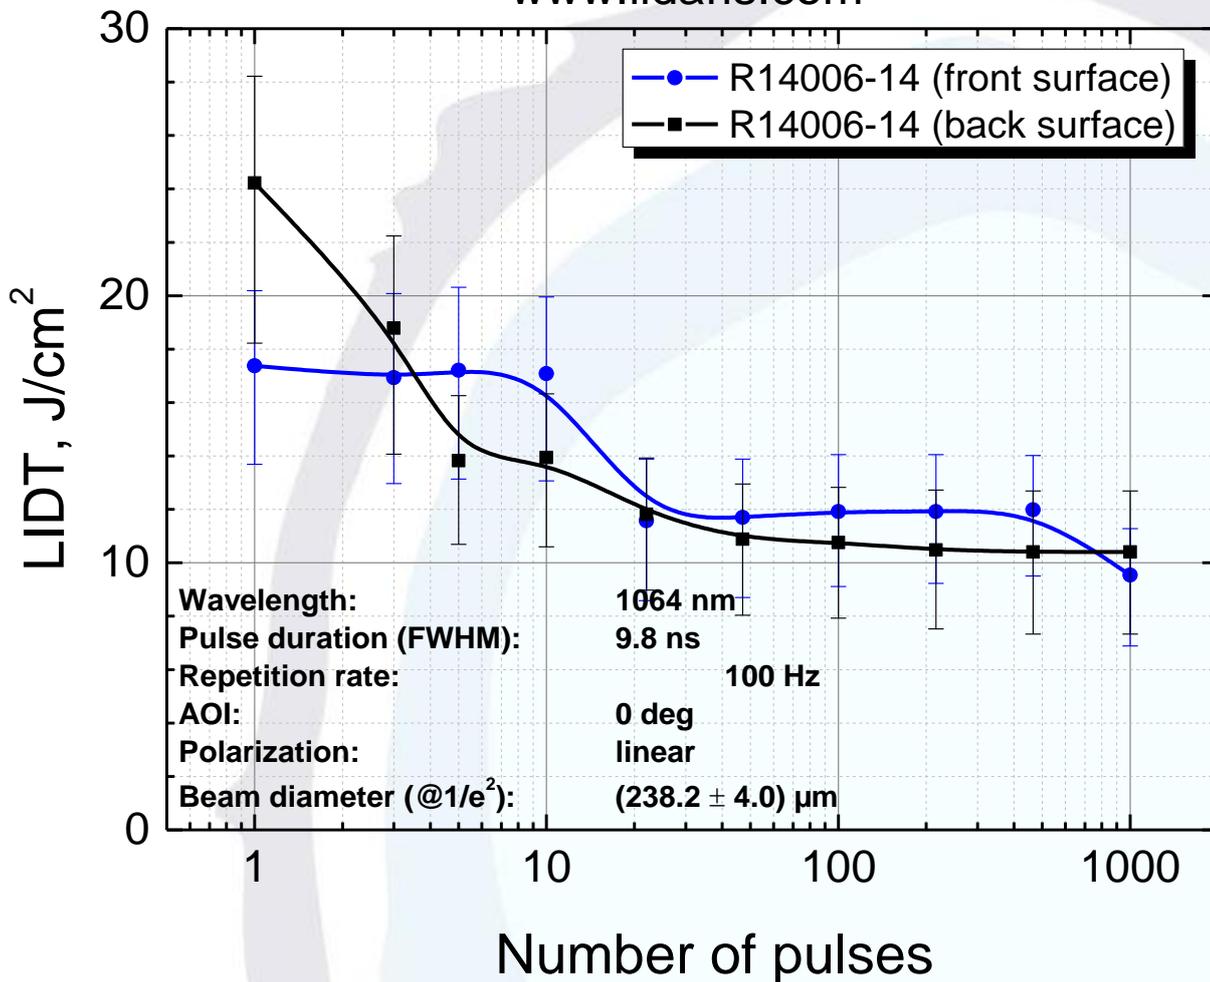
Table 1. Summarized LIDT's for sample R14006-14

Test mode	Threshold - front surface, J/cm <sup>2</sup>	Threshold - back surface, J/cm <sup>2</sup>
1-on-1	3.69 ≤ 17.38 ≤ 2.82	6.00 ≤ 24.22 ≤ 4.00
1000-on-1	2.66 ≤ 9.54 ≤ 1.74	3.07 ≤ 10.41 ≤ 2.28

Fig. 2. Characteristic damage curve.
