# Assurance of energy handling capability in accordance with ISO 21254-3

# **Measurement Report**

Sample: R16075-4

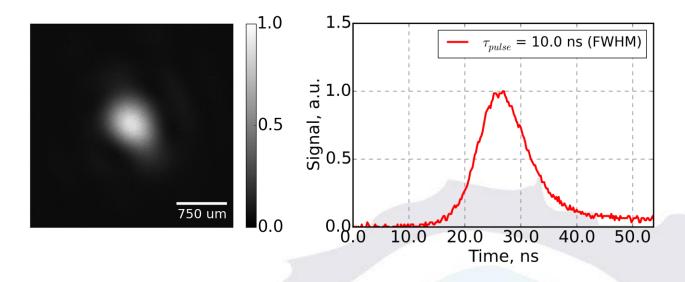
Fig. 1. Spatial beam profile in target plane (left) and temporal pulse profile (right).

Wavelength:	1064 nm
Angle of incidence:	0 deg.
Polarisation state:	linear
Pulse repetition frequency:	100 Hz
Spatial beam profile in target plane:	TEM <sub>00</sub>
Longitudinal beam profile:	Single longitudinal mode (SLM)
Beam diameter in target plane $(1/e^2)$ :	(972.7 ± 33.7) µm (average from 500 pulses)
Pulse duration (FWHM):	$(10.0 \pm 0.4)$ ns (average from 1000 pulses)

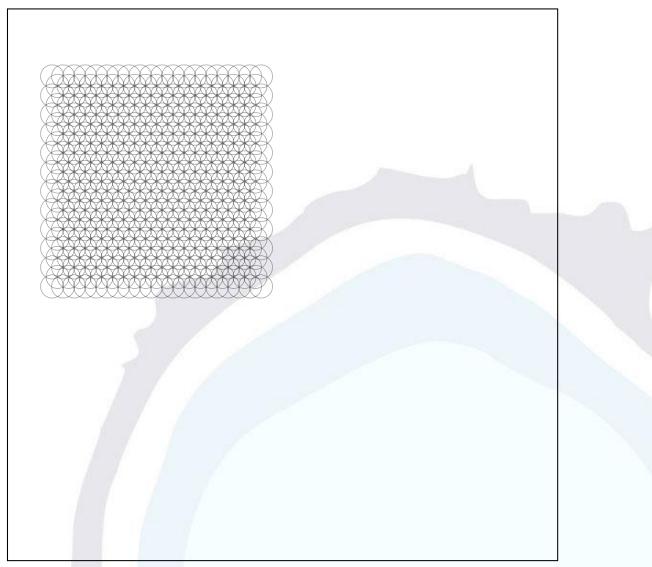
Fig. 2. Arrangement of test sites

3.5, 5, 7.5, 10 J/cm<sup>2</sup> 449 1000 1 cm<sup>2</sup> Hexagon, equally spaced, 50% overlap (Fig 2.) Post-test inspection, Nomarski microscopy Manufacturer's packaging, normal laboratory conditions Industrial environment Dust blown off with clean air
